State of Nevada
Department of Conservation and Natural Resources
Division of State Parks
South Fork State Recreation Area
Facility Condition Analysis

SOUTH FORK STATE RECREATION AREA

Site Number: 9936
STATE OF NEVADA PUBLIC WORKS DIVISION
FACILITY CONDITION ANALYSIS

Report Printed in June 2015

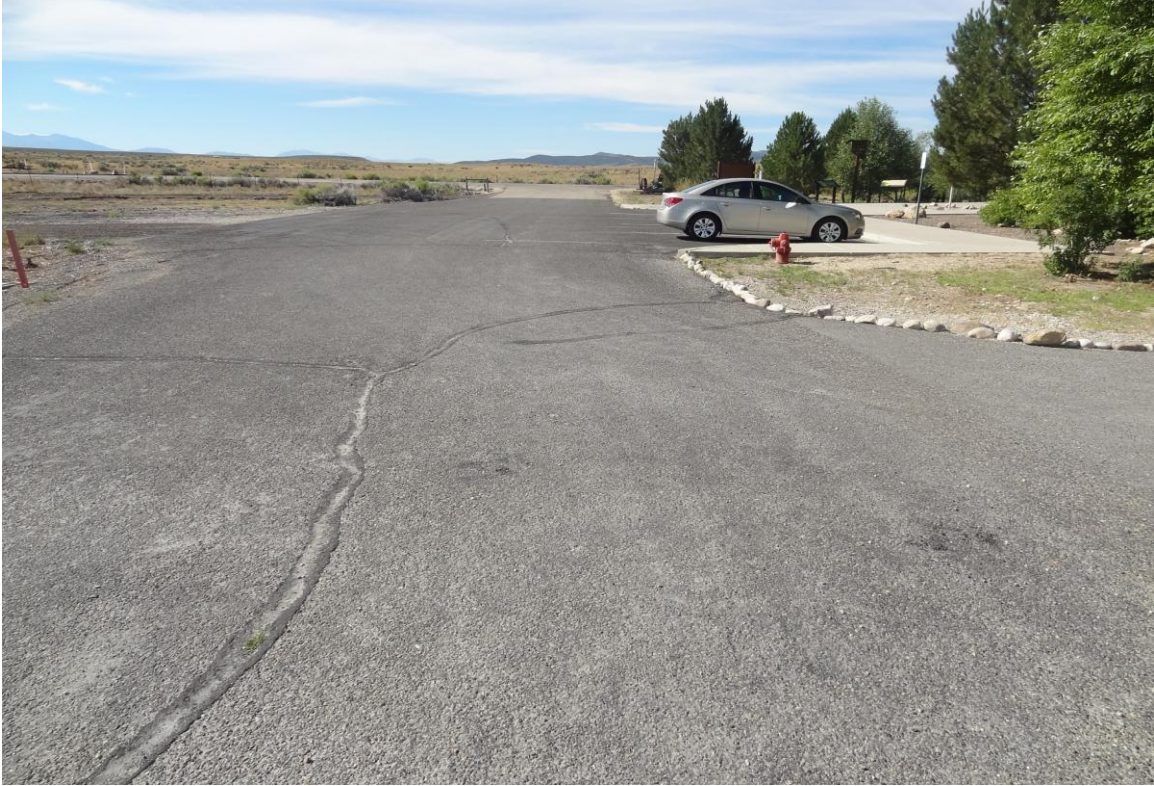
South Fork State Recreation Area Site – FCA Site #9936
Description: AC paving in need of maintenance by park office.

Project Index #: 9936SIT2**Construction Cost \$187,200****CRACK FILL & SEAL ASPHALT PAVING**

It is important to maintain the asphalt concrete paving on the site. This project would provide for minor crack filling and sealing of the paving site wide including access roads and parking areas. Striping is included in this estimate. This project should be scheduled on a 5 year cyclical basis to maintain the integrity of the paving and prevent premature failure.

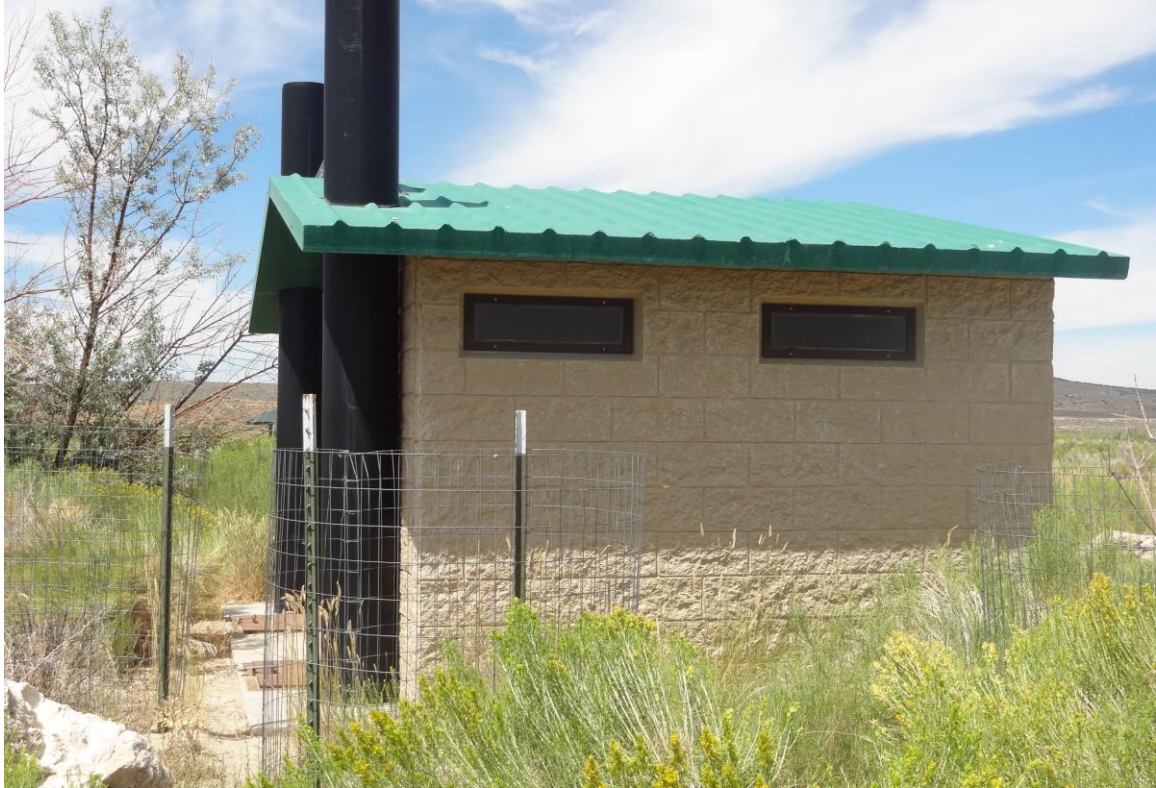
CXT Restroom #2 West – FCA Building #2740

This CXT restroom is a precast double unit which is located in the day use area along the west shore of the reservoir. This unit is somewhat ADA compliant but is lacking an accessible parking area and route of travel to the restroom. It is in excellent condition.

It is important to maintain the finish, weather resistance and appearance of the building. This project would provide funding to protect the interior and exterior of the building. Included in the cost are cleaning and sealing the precast concrete and caulking of the windows, flashing, fixtures and all other penetrations. An epoxy paint is recommended on the interior precast concrete. It is recommended that the building be sealed and caulked in the next 5-7 years and that this project is scheduled on a cyclical basis to maintain the integrity of the structure.

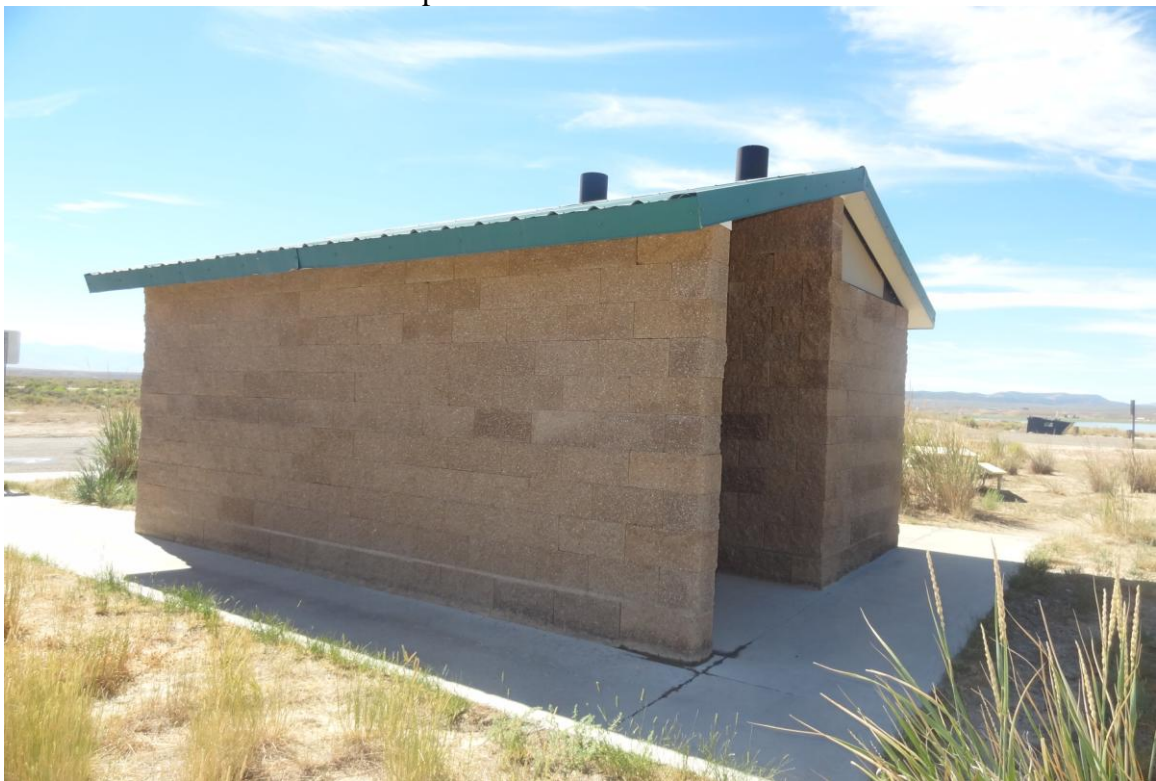
East Boat Ramp CXT Restroom – FCA Building #2321
Description: Exterior of the restroom.

The East Boat Ramp CXT Restroom is located in the boat ramp parking and day use area. This concrete masonry unit structure is ADA complaint and has stalls for men and women. It is in excellent condition.

The Americans with Disabilities Act (ADA) provides for accessibility to sites and services for people with physical limitations. The asphalt parking area and passenger loading area are missing proper signage and striping to comply with ADA requirements. This project would provide for striping, signage and any other necessary upgrades to the parking space. The 2012 IBC, ICC/ANSI A117.1 - 2009, NRS 338.180 and the most current version of the ADA Standards For Accessible Design were used as a reference for this project.

It is important to maintain the finish, weather resistance and appearance of the building. This project would provide funding to protect the interior and exterior of the building. Included in the cost are cleaning and sealing the precast concrete and caulking of the windows, flashing, fixtures and all other penetrations. An epoxy paint is recommended on the interior precast concrete. It is recommended that the building be sealed and caulked in the next 2-3 years and that this project is scheduled on a cyclical basis to maintain the integrity of the structure.

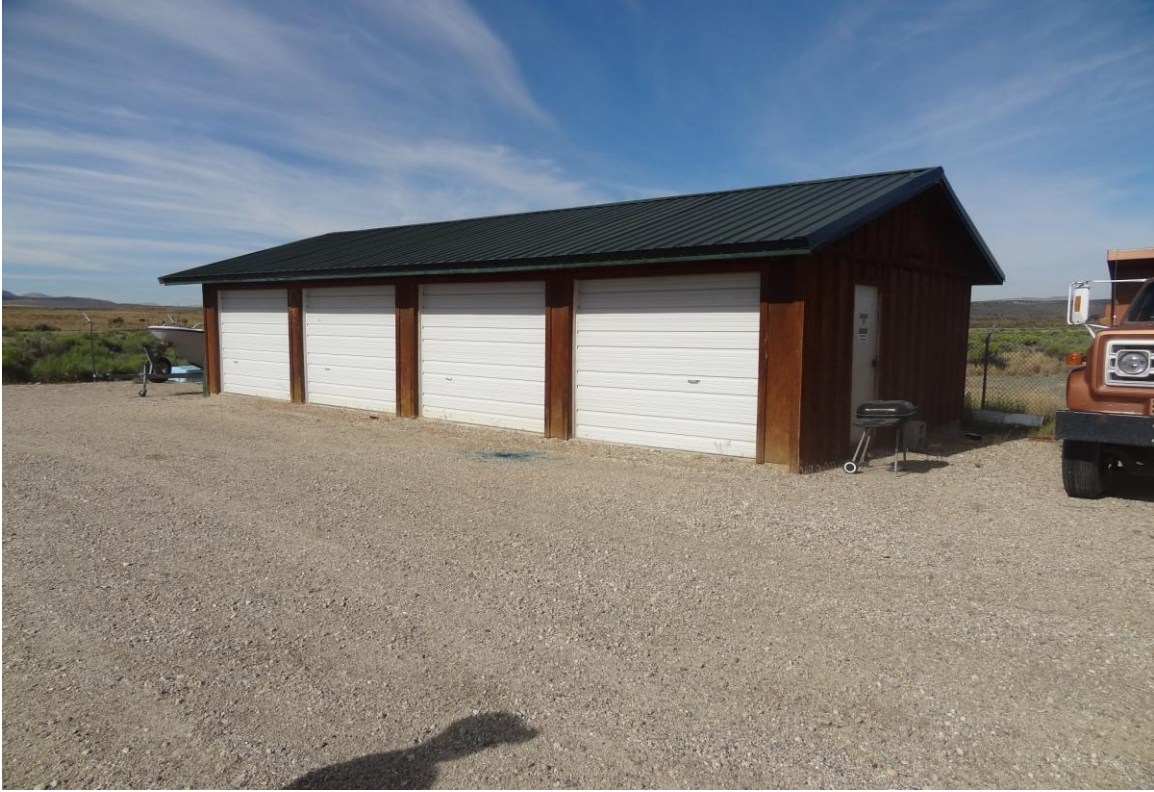
Garage / Storage Building – FCA Building #2301
Description: Exterior of the building.

The Garage / Storage building is a wood framed structure on a concrete slab-on-grade foundation. Primarily designed as a garage, it is currently used as storage for park maintenance personnel. It is located in the park office yard and is in good condition.

The exterior wood man door appears to be original to the building. It is damaged from age and general wear and tear. The frame has not held up over time and is causing the door to bind. This project would provide for the replacement of the wood door with a new metal door, frame and hardware. Removal and disposal of the existing door and painting of the new door is included in this estimate.

It is important to maintain the finish, weather resistance and appearance of the building. This project would provide funding to protect the exterior of the building excluding the roof. Included in the cost is power washing and staining the wood and caulking of the flashing, fixtures and all other penetrations. It is recommended that the building be stained and caulked in the next 2-3 years and that this project is scheduled on a cyclical basis to maintain the integrity of the structure. This project or a portion thereof was previously recommended in the FCA report dated 11/07/2007. It has been amended accordingly to reflect conditions observed during the most recent survey date of 07/22/2014.

The interior finishes are in fair condition. It is recommended to paint the interior walls and ceilings at least once in the next 2-3 years and that this project is scheduled on a cyclical basis to maintain the integrity of the structure. Prior to painting, all surfaces should be repaired and prepped.

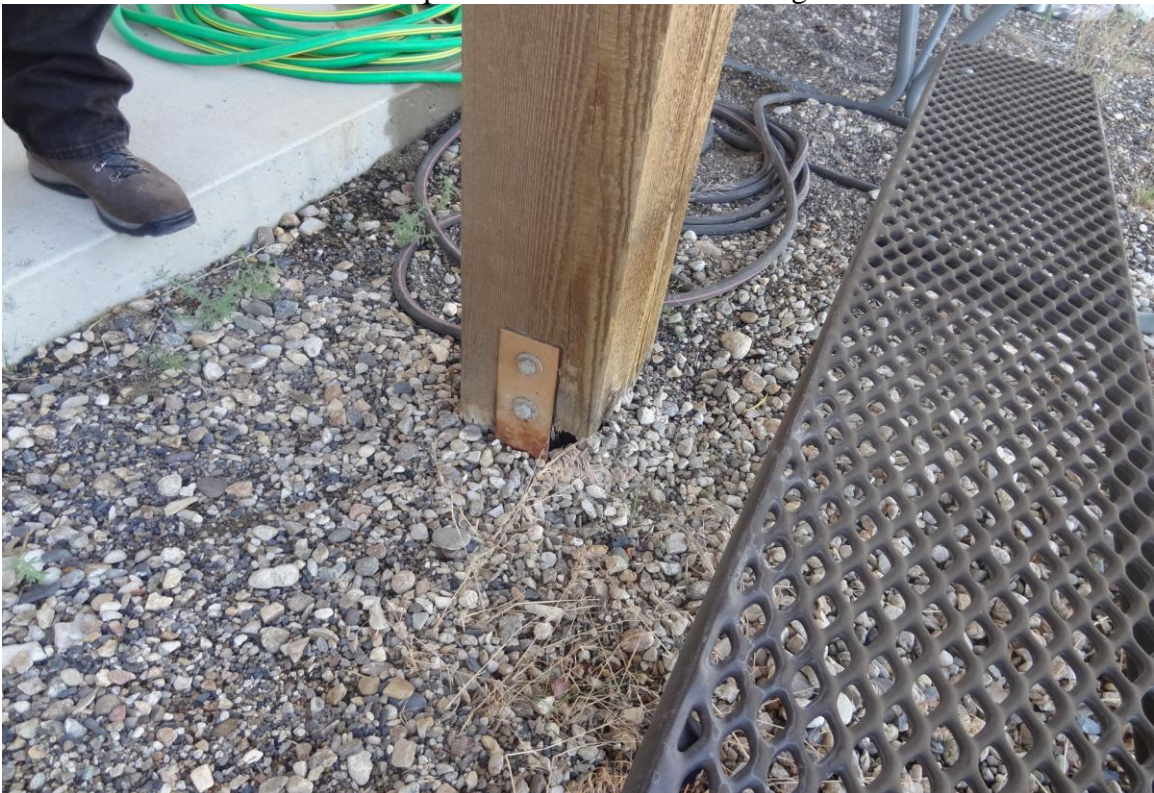
Park Office / Shop – FCA Building #0547
Description: Damaged pier post / footing.
